Barrio Logan and Western Southeast San Diego

Historical Survey

BARRIO LOGAN
AND
WESTERN SOUTHEAST SAN DIEGO
HISTORICAL SURVEY

June 1980

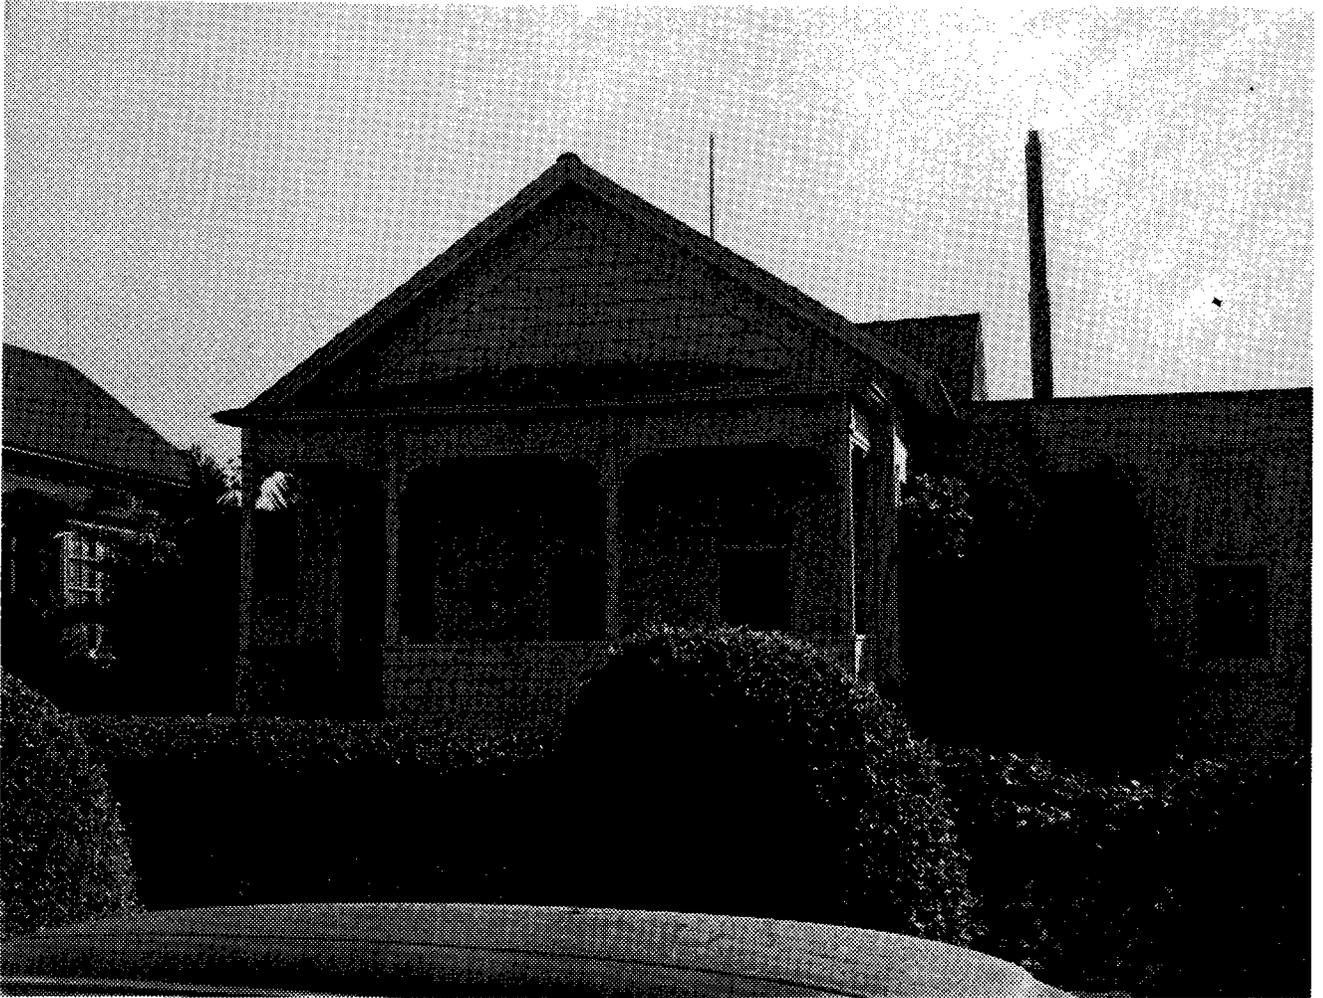
2765 BOSTON AVENUE

This is an example of the Colonial Revival style of architectural design. It possesses the classical columns, the low pitched hip roof and dentils under the eaves. It appears much as it was originally, except for some deterioration and siding alterations.

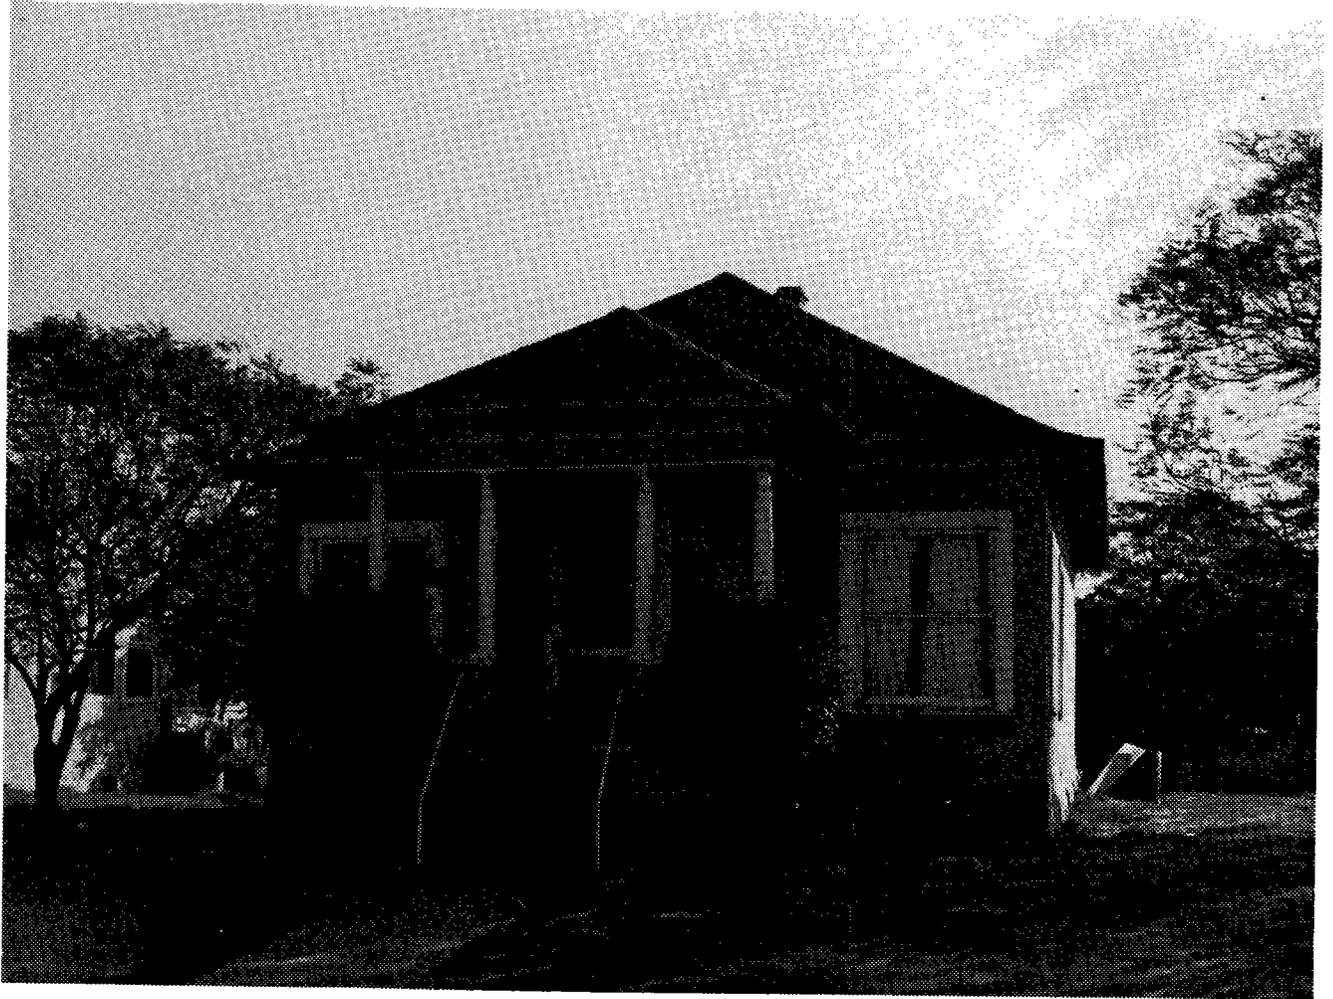
2851 BOSTON AVENUE

6. Briefly describe the present physical appearance of the site or structure and describe any major alterations from its original condition:
Plain in appearance, this house is structurally sound. It is well maintained. The exterior has been stuccoed.

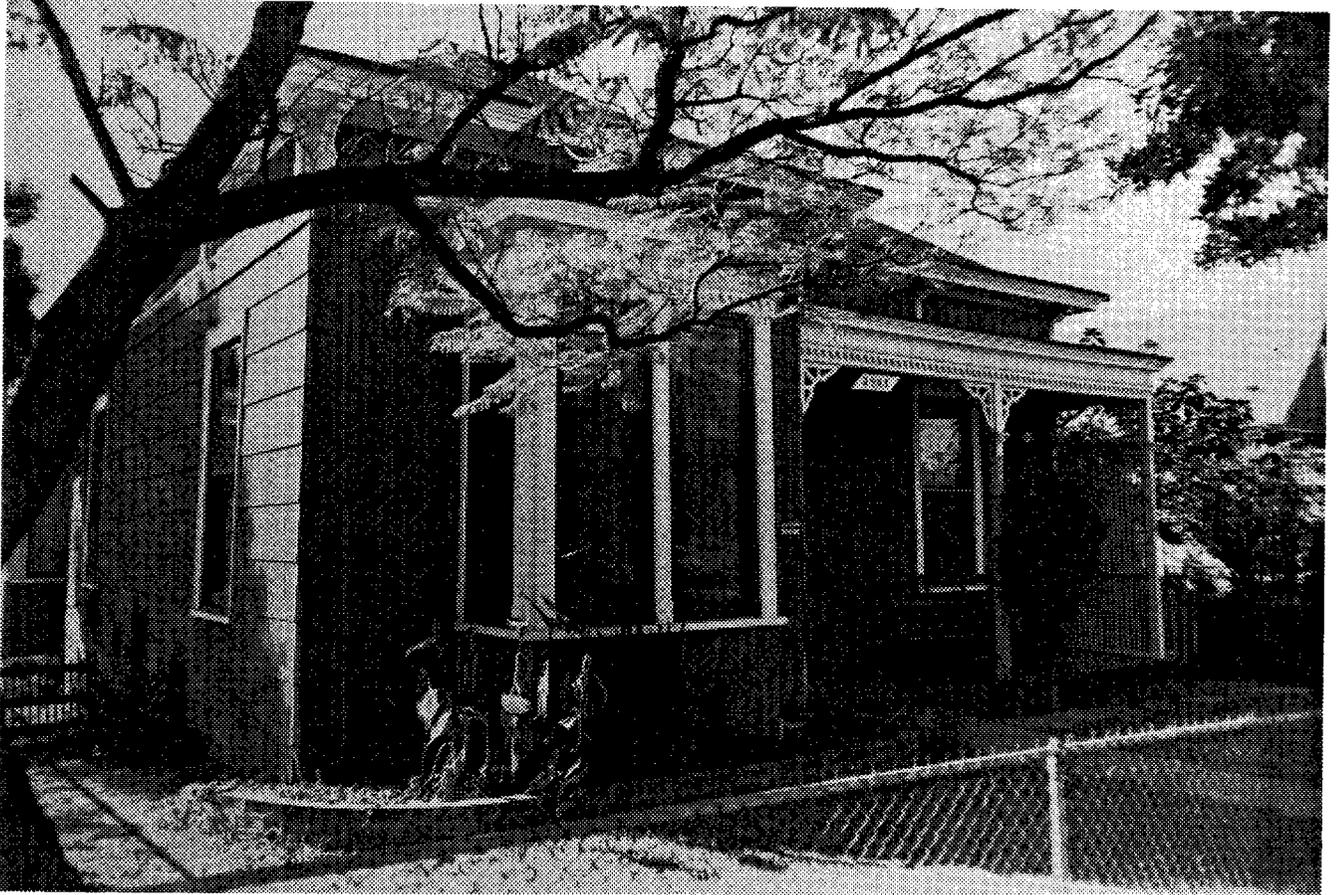
2981 BOSTON AVENUE

The house is in fairly good condition but the architectural style is overwhelmed by alterations. Vegetation and a chain link fence surround the site. This is an example of a Neoclassic Row house and includes very simple qualities such as the simple box like plan, a small porch and very little decoration.

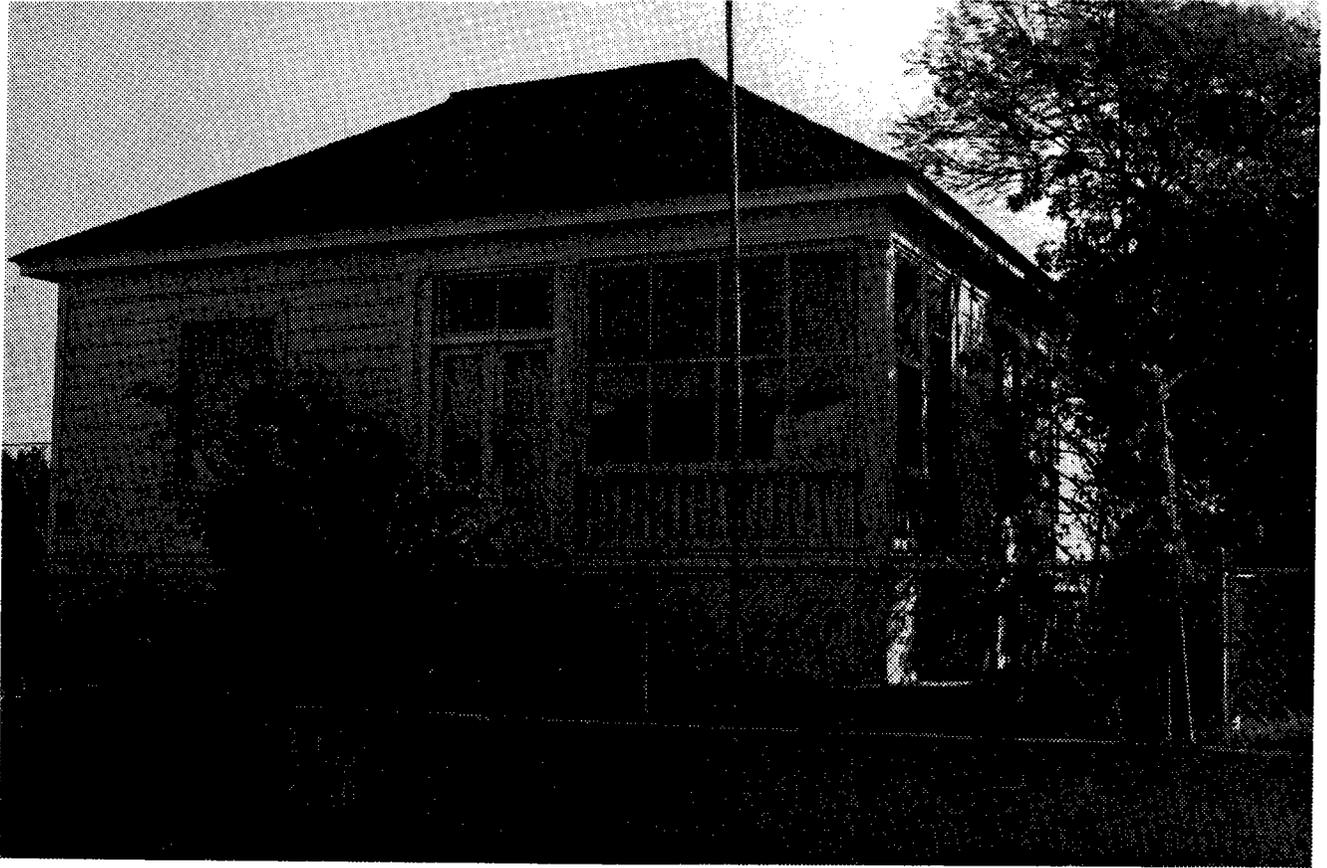
3019 BOSTON AVENUE

This house possesses characteristics of two styles of design. The front is typical Queen Anne with the fish scale shingle and the high pitched gable roof. The rest of structure is reminiscent of the Colonial Revival style with its hip roof and the narrow rectangular windows. Some deterioration has occurred.

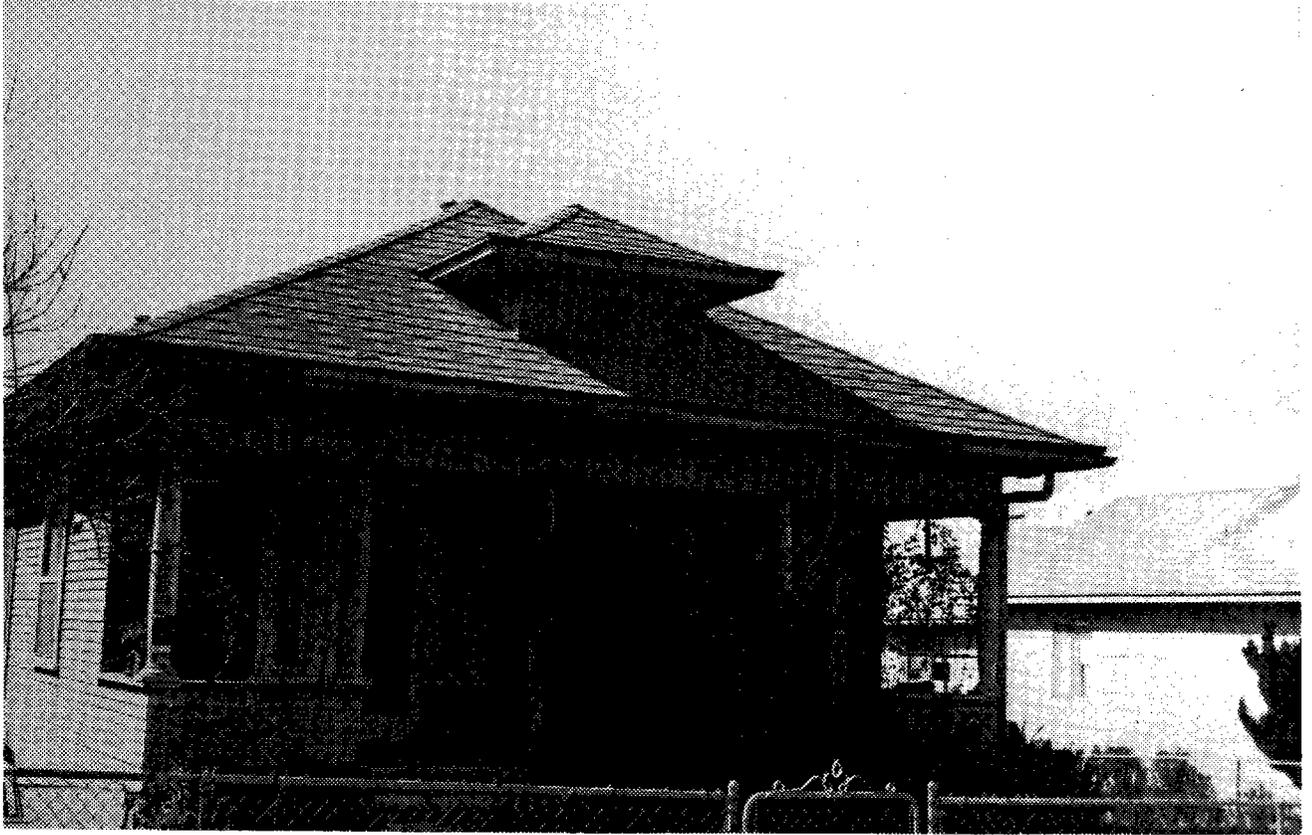
1969 HARRISON AVENUE

- Briefly describe the present physical appearance of the site or structure and describe any major alterations from its original condition:
 This structure appears to be a low cost Queen Anne cottage. It possesses the usual fish scale shingle, the high pitched gable roof and the long rectangular windows. The porch has been altered. The banister, stairs and facing are not original. The house appears to be structurally sound and is being maintained reasonably well. The siding also appears to have been redone.

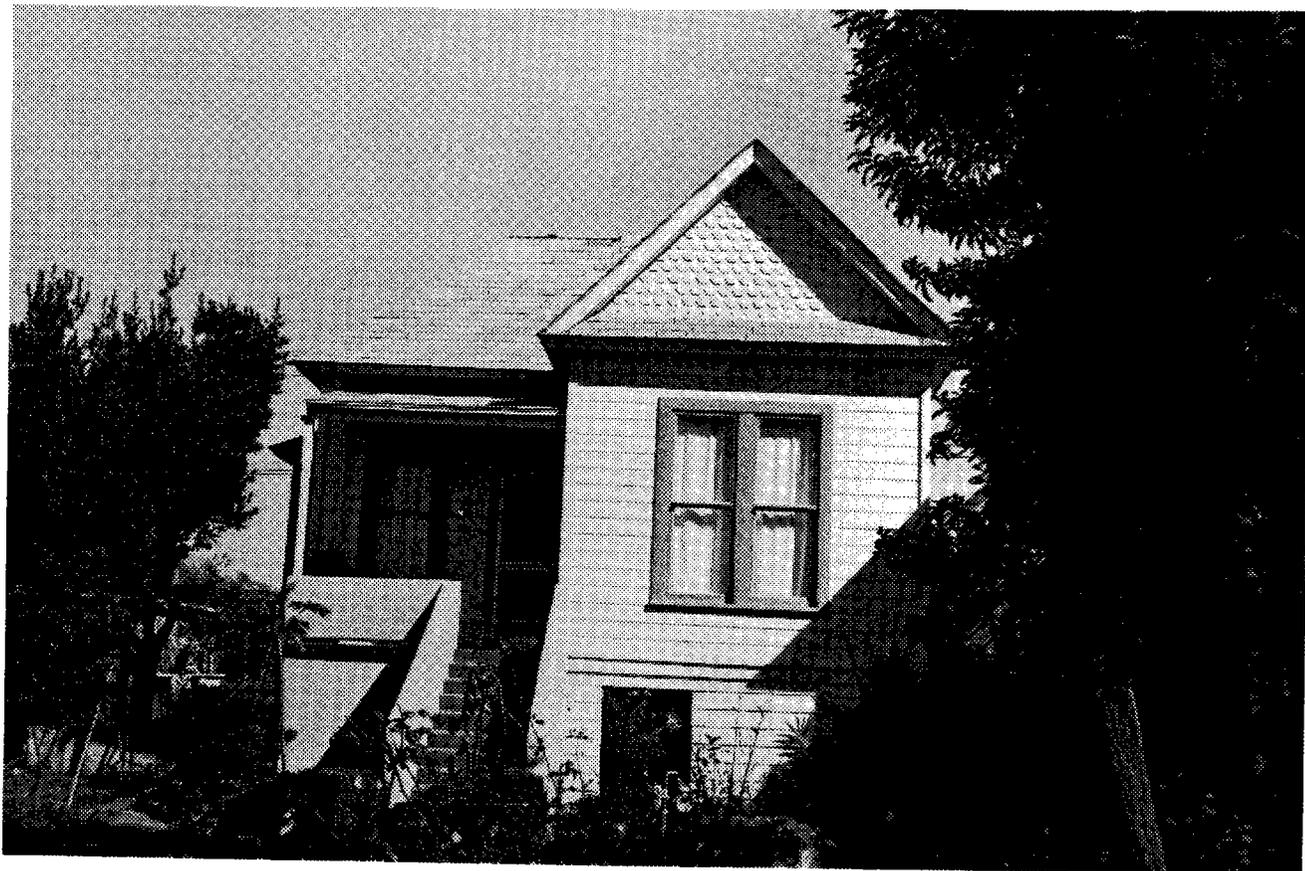
2070 HARRISON AVENUE

This house is an excellent example of the Colonial Revival style. It possesses the front dormer, the classical columns and the low pitched hip roof. The broad flat eaves, the narrow clapboard siding are also traditional characteristics of this style. The house is in good condition. The only apparent alteration is that the porch extending across the entire front of the house has been enclosed.

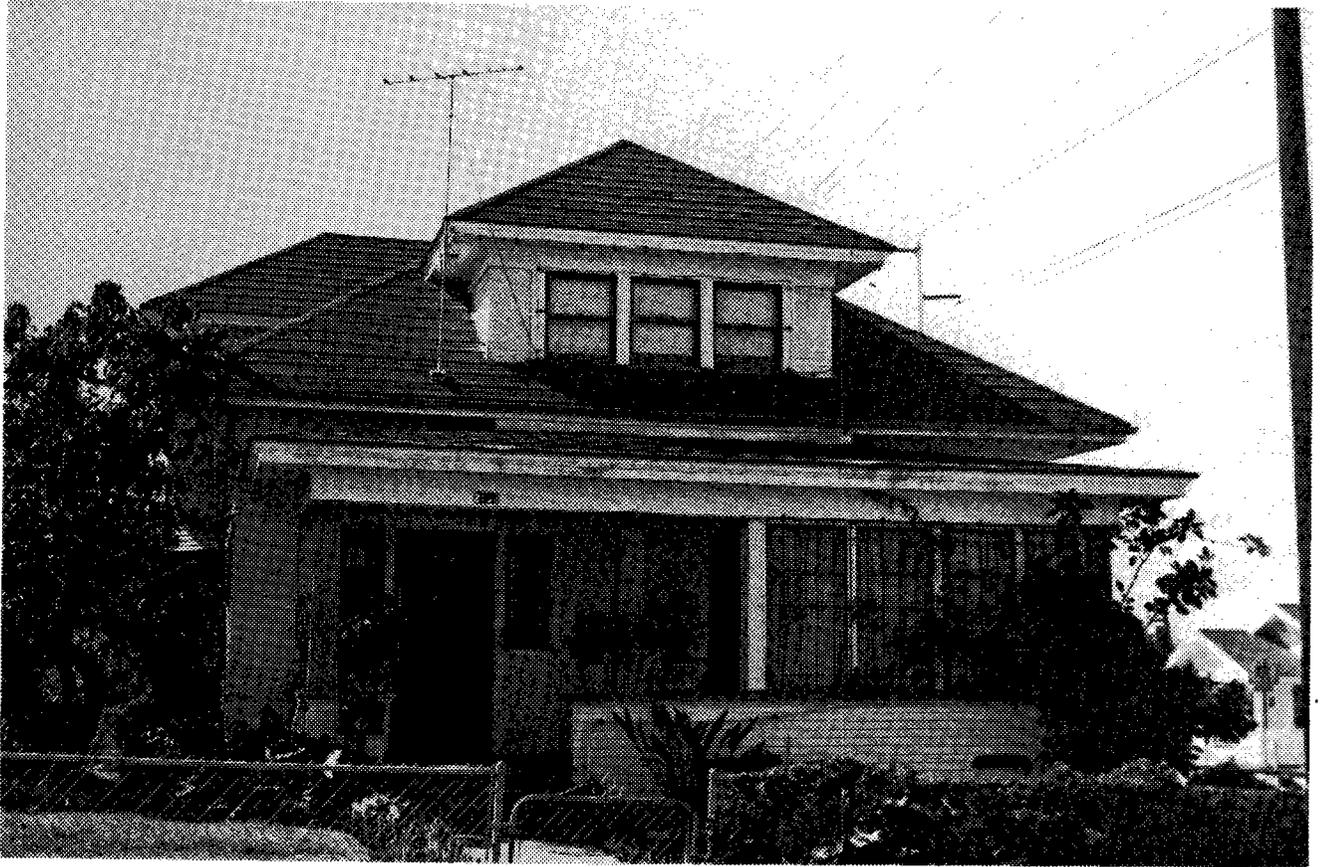
2103 HARRISON AVENUE

In 1923, Erasmus and Louise Johnson owned and lived at this site. In 1932, it became a rental unit until Mrs. J. Spencer purchased it in 1943. In 1947, James W. Lockett acquired the property. In 1966, ownership was transferred to his wife Mrs. Julia L. Lockett. In 1976, Dudley Spencer, who had lived there in 1953, is the tenant on record. This structure, although altered, displays much of the typical feature of the Craftsman style. It is in good condition and would be easily preserved with proper maintenance.

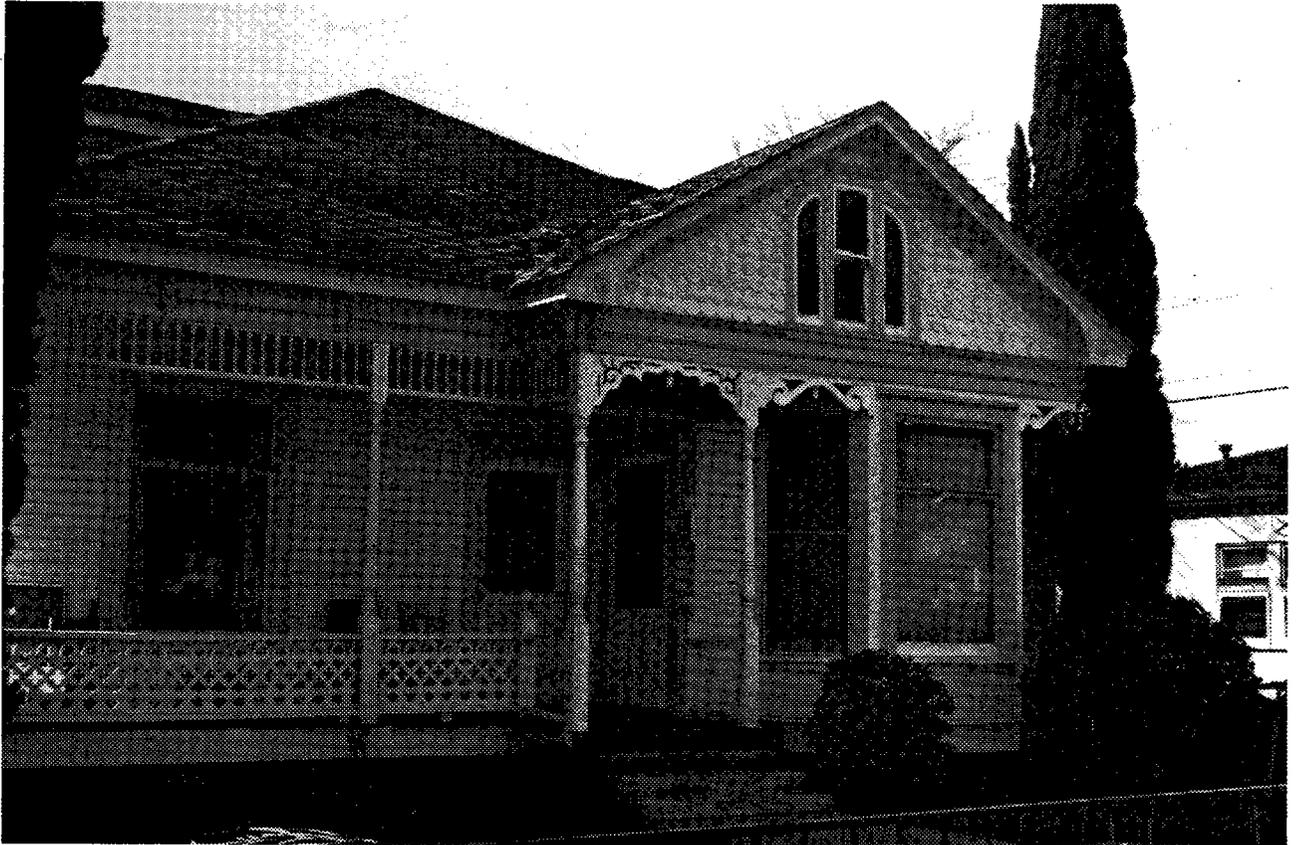
2211 IRVING AVENUE

This structure belongs to the Craftsman style of design, very prevalent throughout San Diego between 1905 and 1925. It displays many traditional features, such as, the exposed roof rafters, the front dormer, the gable roof of varying pitch, the clinker brick chimney and the diamond paned front windows. The house has had an outside stairway and upstairs entrance added on. The original siding has been replaced.

From 1927 to 1933, Mrs. C.C. Schneider owned this site. It became a rental unit until 1939, when N.G. Profeta bought it. During World War II it again became a rental unit. In 1948, K.M. Fields, its present owner, purchased it. He has maintained the property well. Most of the original features are present today. This structure is worthy of preservation due to its good, nearly original condition. This is one of the better examples of the Craftsman cottage.

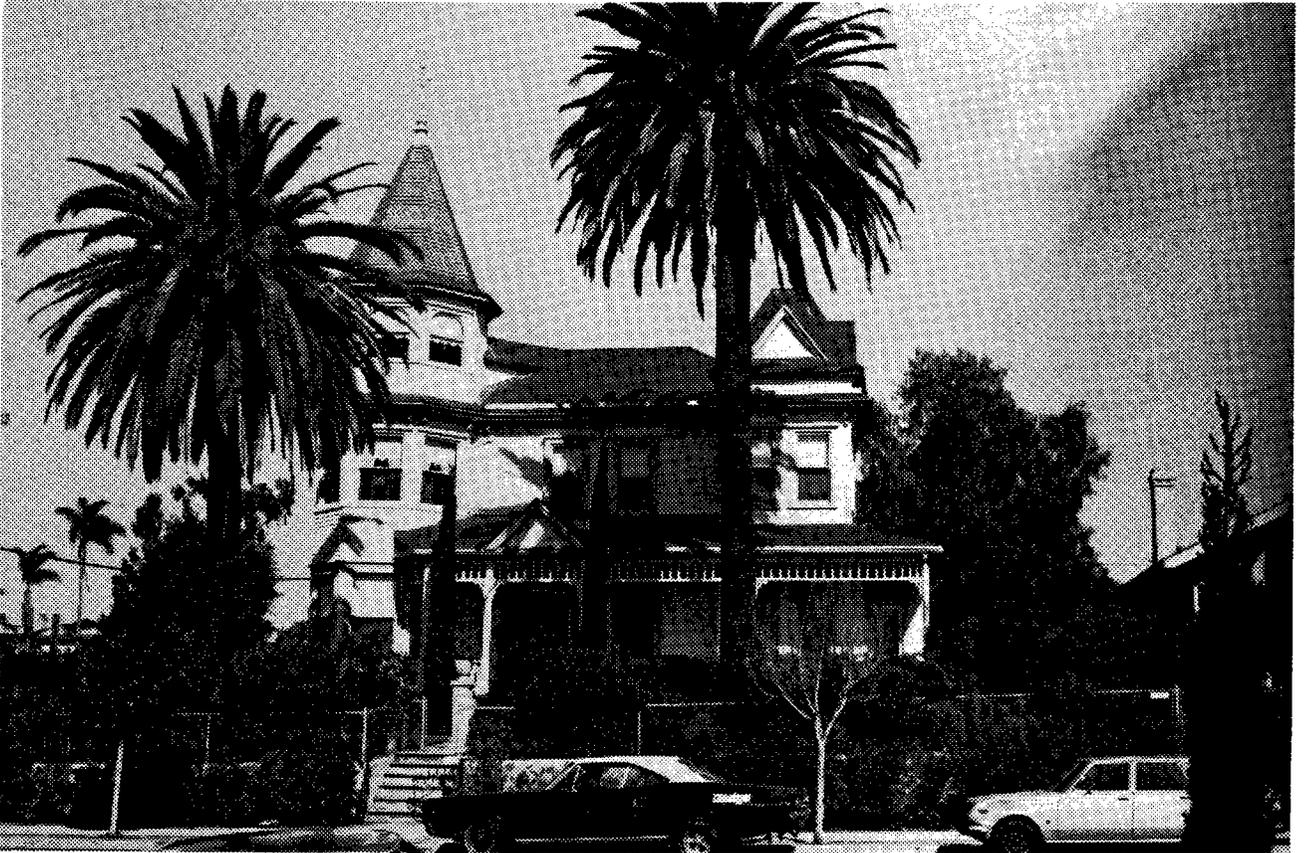
2412 "J" STREET

This house is a two story Queen Anne without turret. The siding has been redone. The large rectangular windows and the high pitched gable roof are typical of this style. Detailing, also typical of this style, includes the ornate woodwork above the porch and the decorative barge board. An unusual characteristic of this house are the narrow windows at one end. The stained glass is another notable feature.

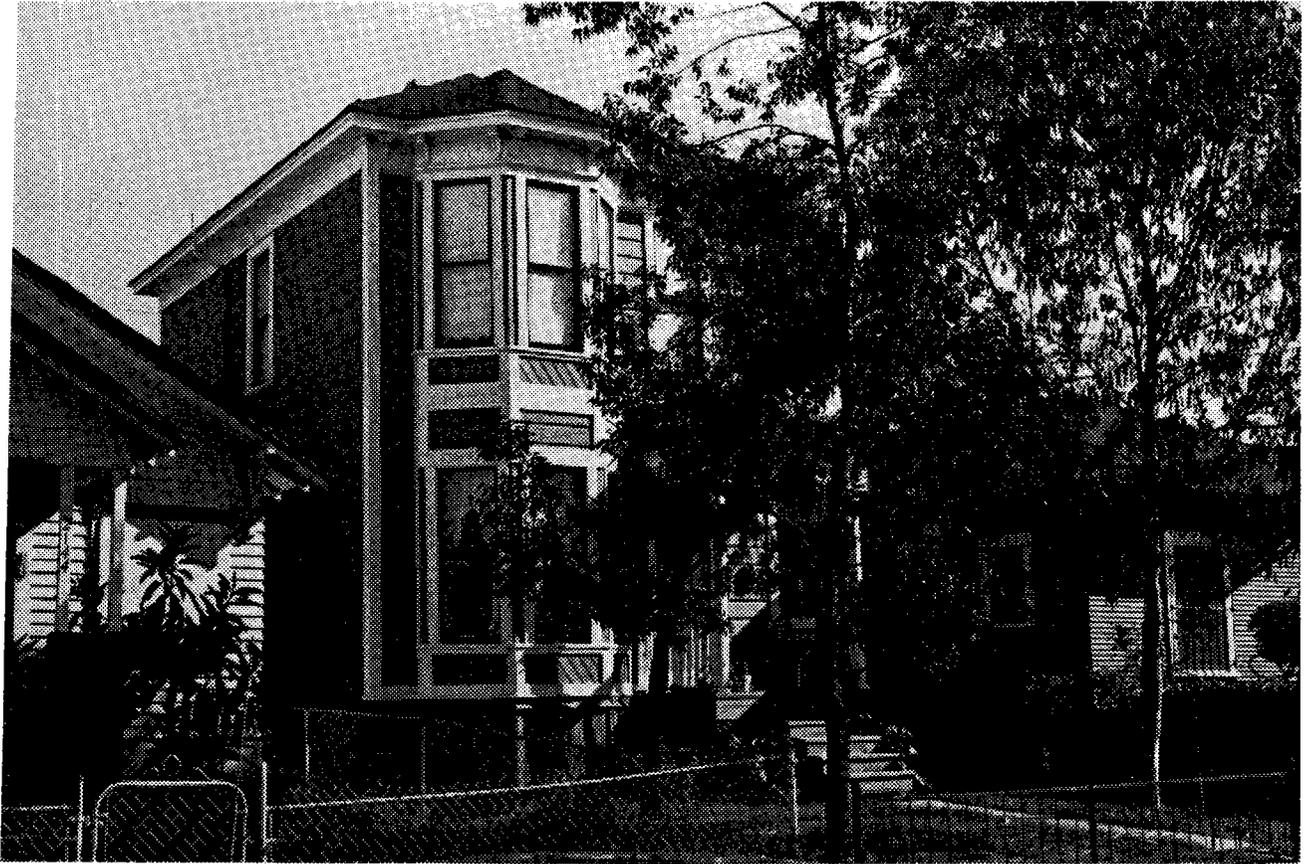
2146 NEWTON AVENUE

This is a variety of the Classic Box. Some deterioration has occurred. The porch is an addition to the house. It has also been enclosed on one end.

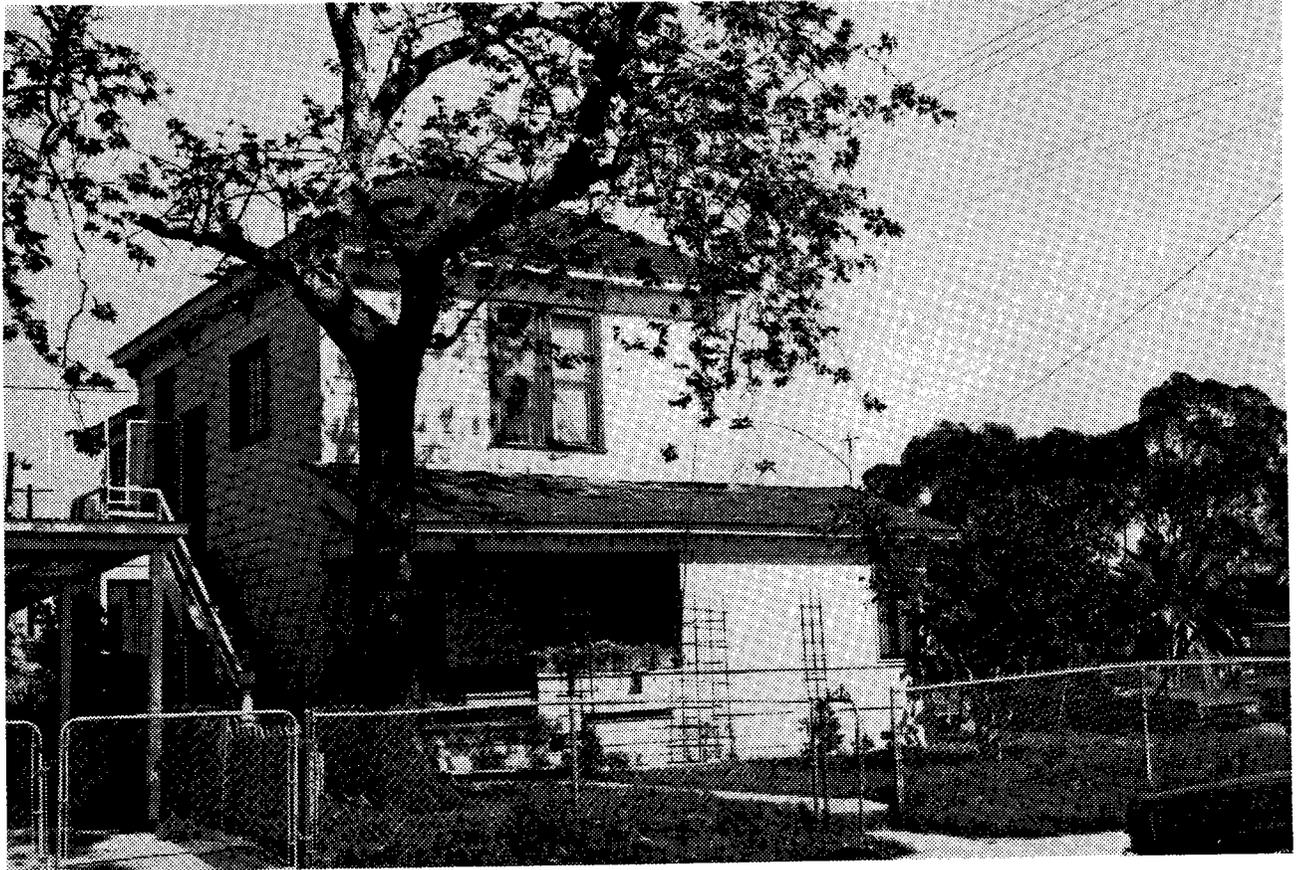
2696 NEWTON AVENUE

This building incorporates features of different architectural styles. The fish scale shingle and decorative side porch are characteristic of the Queen Anne style along with the irregular elevation gable roof. The house has deteriorated some but generally seems to be a sound structure. The rectangular bay window is characteristic of the Italianate style.

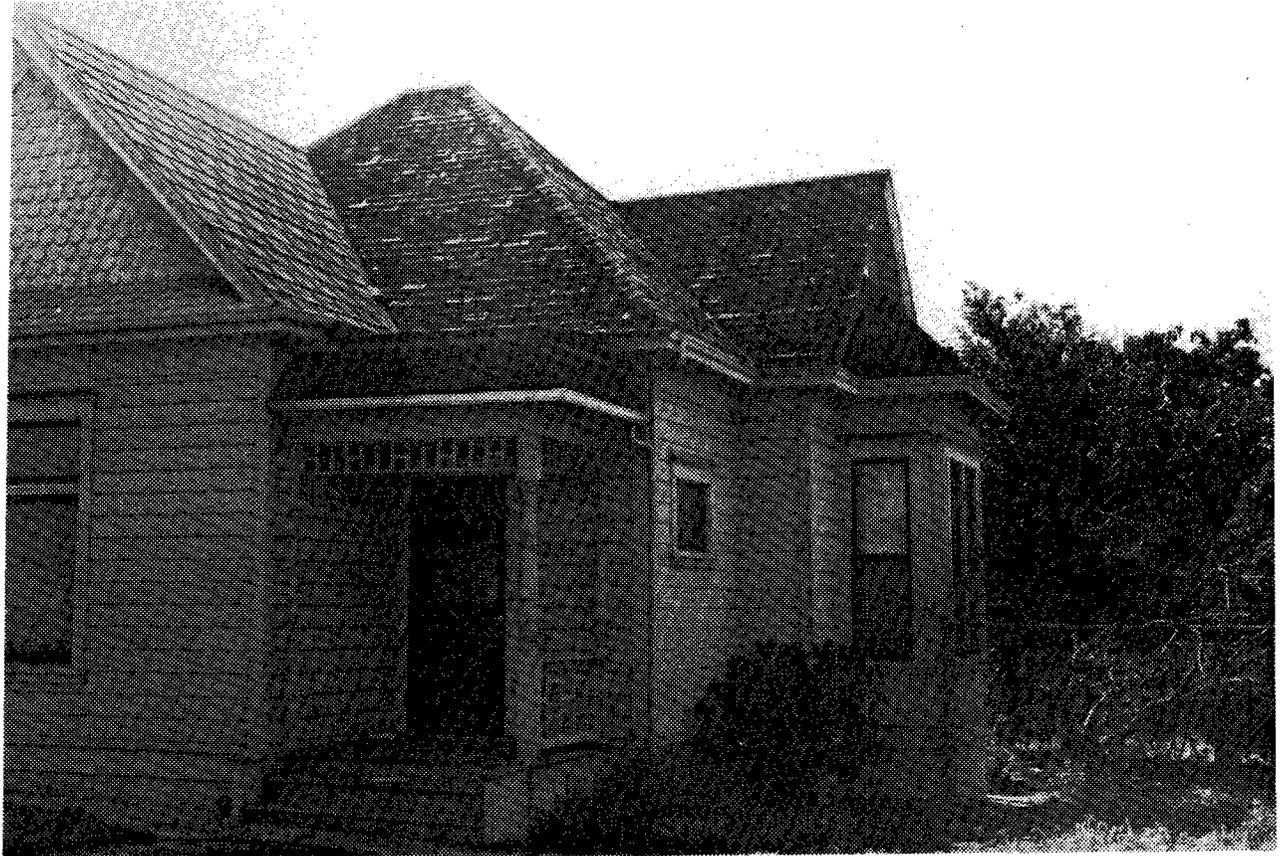
2055 OCEANVIEW BOULEVARD

This Queen Anne cottage displays such traditional features as the high pitched gable roof, the fish scale shingle, the decorated side porch and the tall rectangular windows. The porch roof has been replaced and the ends of the porch have been enclosed. The house has deteriorated some and the alterations not in character with the rest of the structure have reduced much of the original charm.

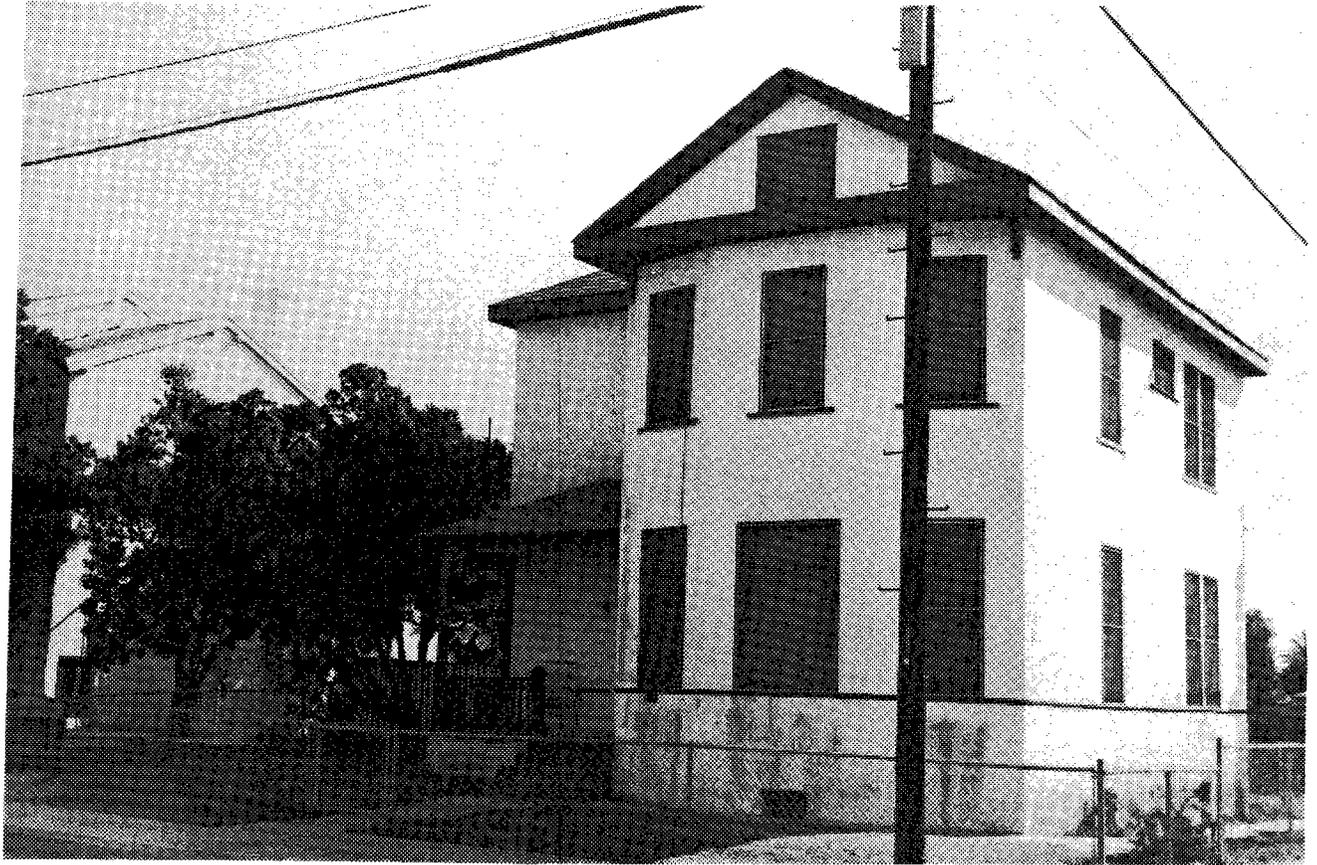
515 SAMPSON STREET

This structure is an example of the Craftsman style of design. The typical features it possesses are, the exposed roof rafters, the dormer with vent, the clinker brick chimney, the small paned windows and doors, and the hip roof. The brick facing on the exterior of the house is not original. This property has not been maintained well. The roof is sagging and deterioration is obvious, particularly around the dormer and the buildings exterior.

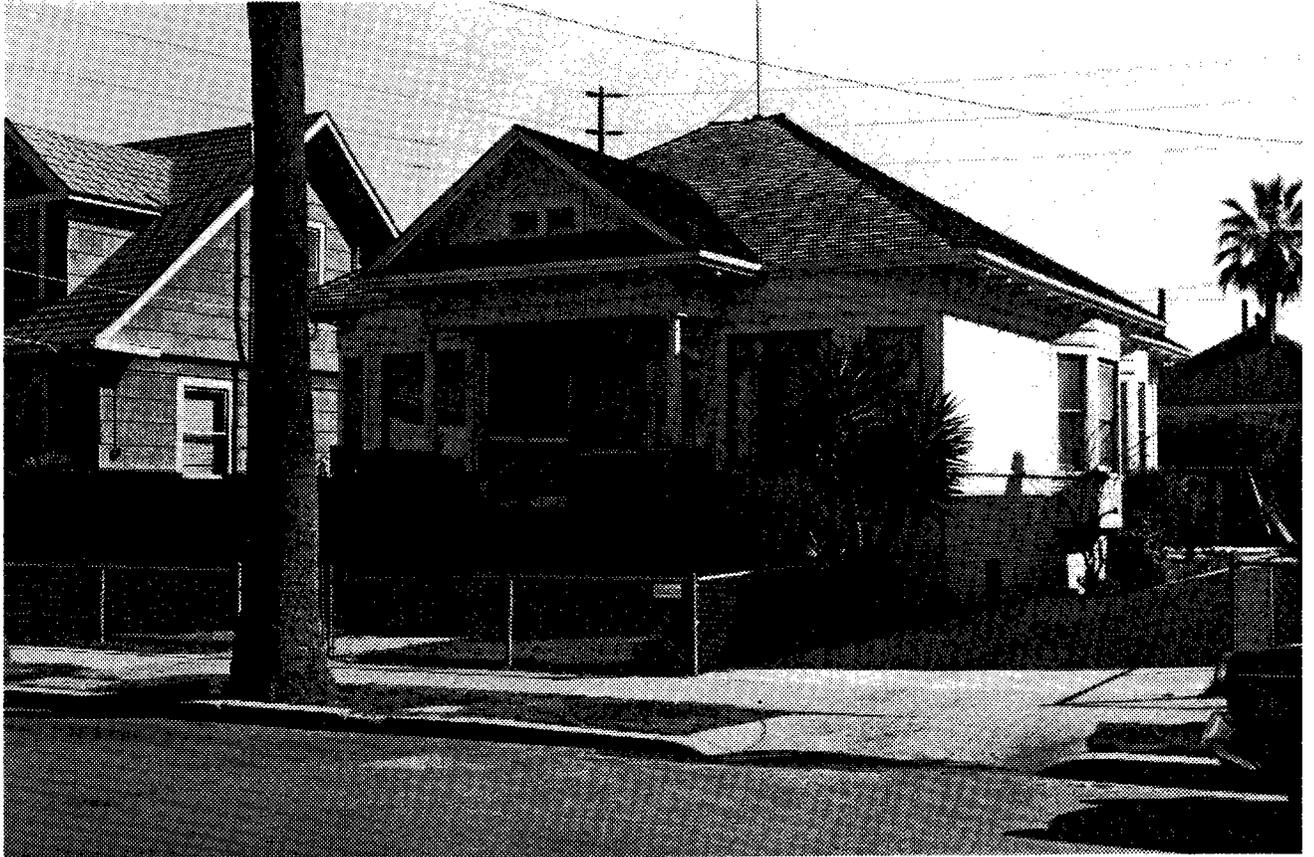
443 NORTH 21ST STREET

This site is an example of the Colonial Revival style of design. It remains in good condition. Although it was initially a low cost structure, it has withstood the years in excellent fashion. Maintenance has obviously been consistent. It displays such typical characteristics as the classic columns, the low pitched roof, the shallow polygonal bay, the diamond patterned leaded glass and the broad flat eaves.

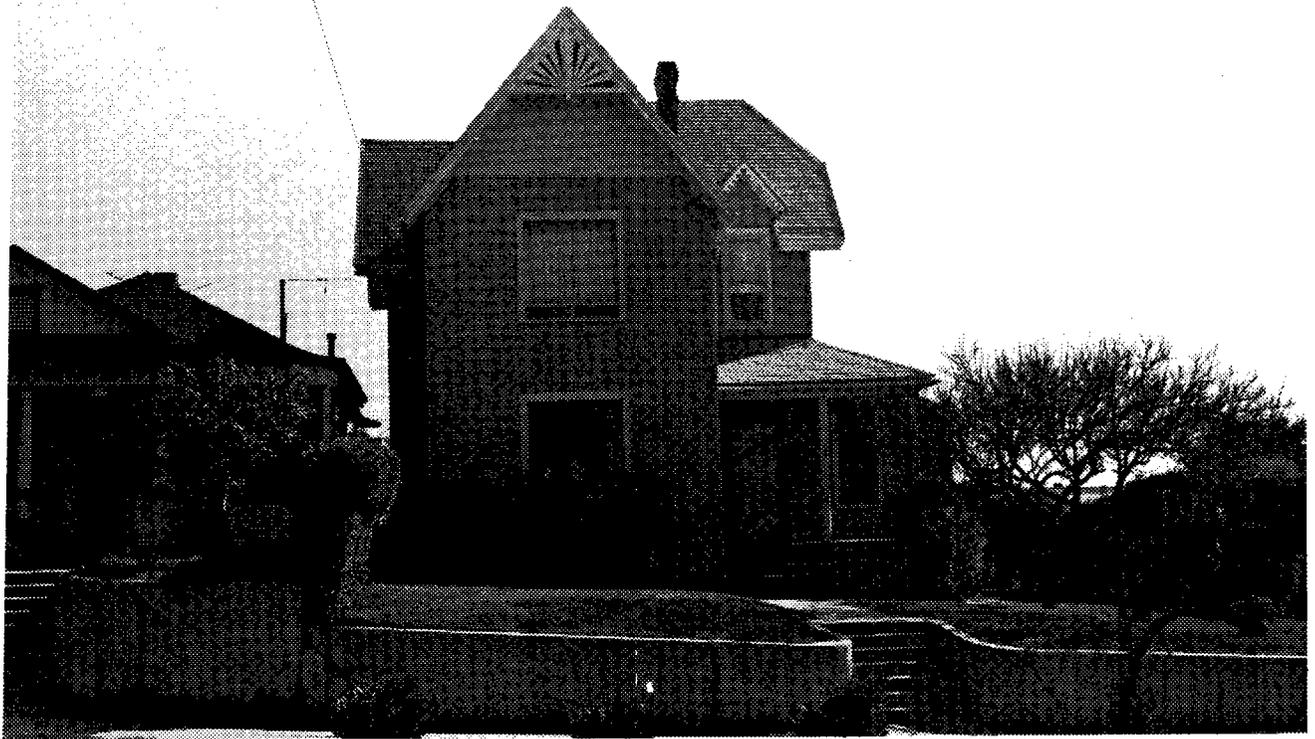
405 NORTH 27TH STREET

This site was first listed in the City Directory in 1939. At that time W.N. Frank was the resident. This would indicate that the house has been moved, as its style dates it to a period between 1895 and 1915. In 1952 James Casal became the new owner resident and his wife Ruth is the present owner. This house is in very good condition and is being maintained well. No apparent alteration is visible. It is an excellent example of the Colonial Revival style.
